CF-DRD has stood in Norseman Heritage Park on Red Lake's Waterfront since 1992. It is a UC-64A (Mark VI) Norseman produced by Noorduyn Aviation Limited (as serial #831) for the United States Army Air Force which took delivery of it on May 4, 1945.

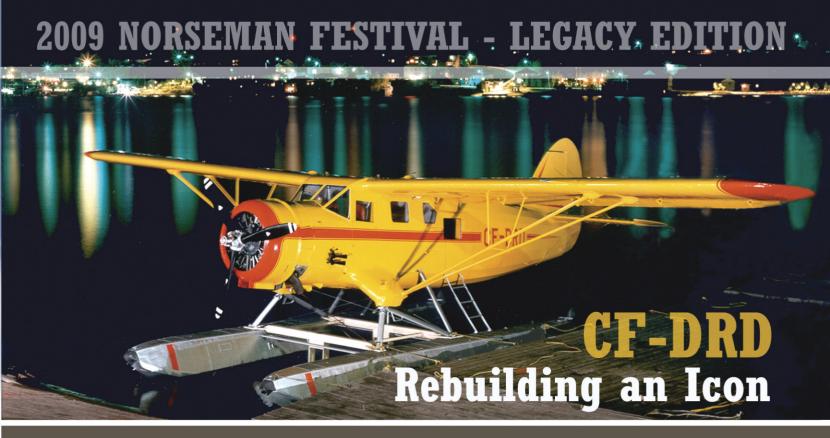
Following it's last run under power on June 28, 1992, the fully restored CF-DRD was returned to the dock at Red Lake Seaplane on Howey Bay. On Canada Day, with the sound of fireworks going off in the background, Don Nord took this historic night shot of DRD ready to assume its new role as icon. The solid rigging for mounting it on its pedestal is already attached between the floats and hardly looks out of place on Noorduyn's tough and durable aircraft.
